TRANSPORTATION PROBLEMS AND NEEDS IN THE AFTERMATH OF THE
1985 MEXICO CITY EARTHQUAKE

Antoine Hobeika
Siamak Ardekani
Alejandro Martinez-Marquez

1987

Quick Response Research Report #10

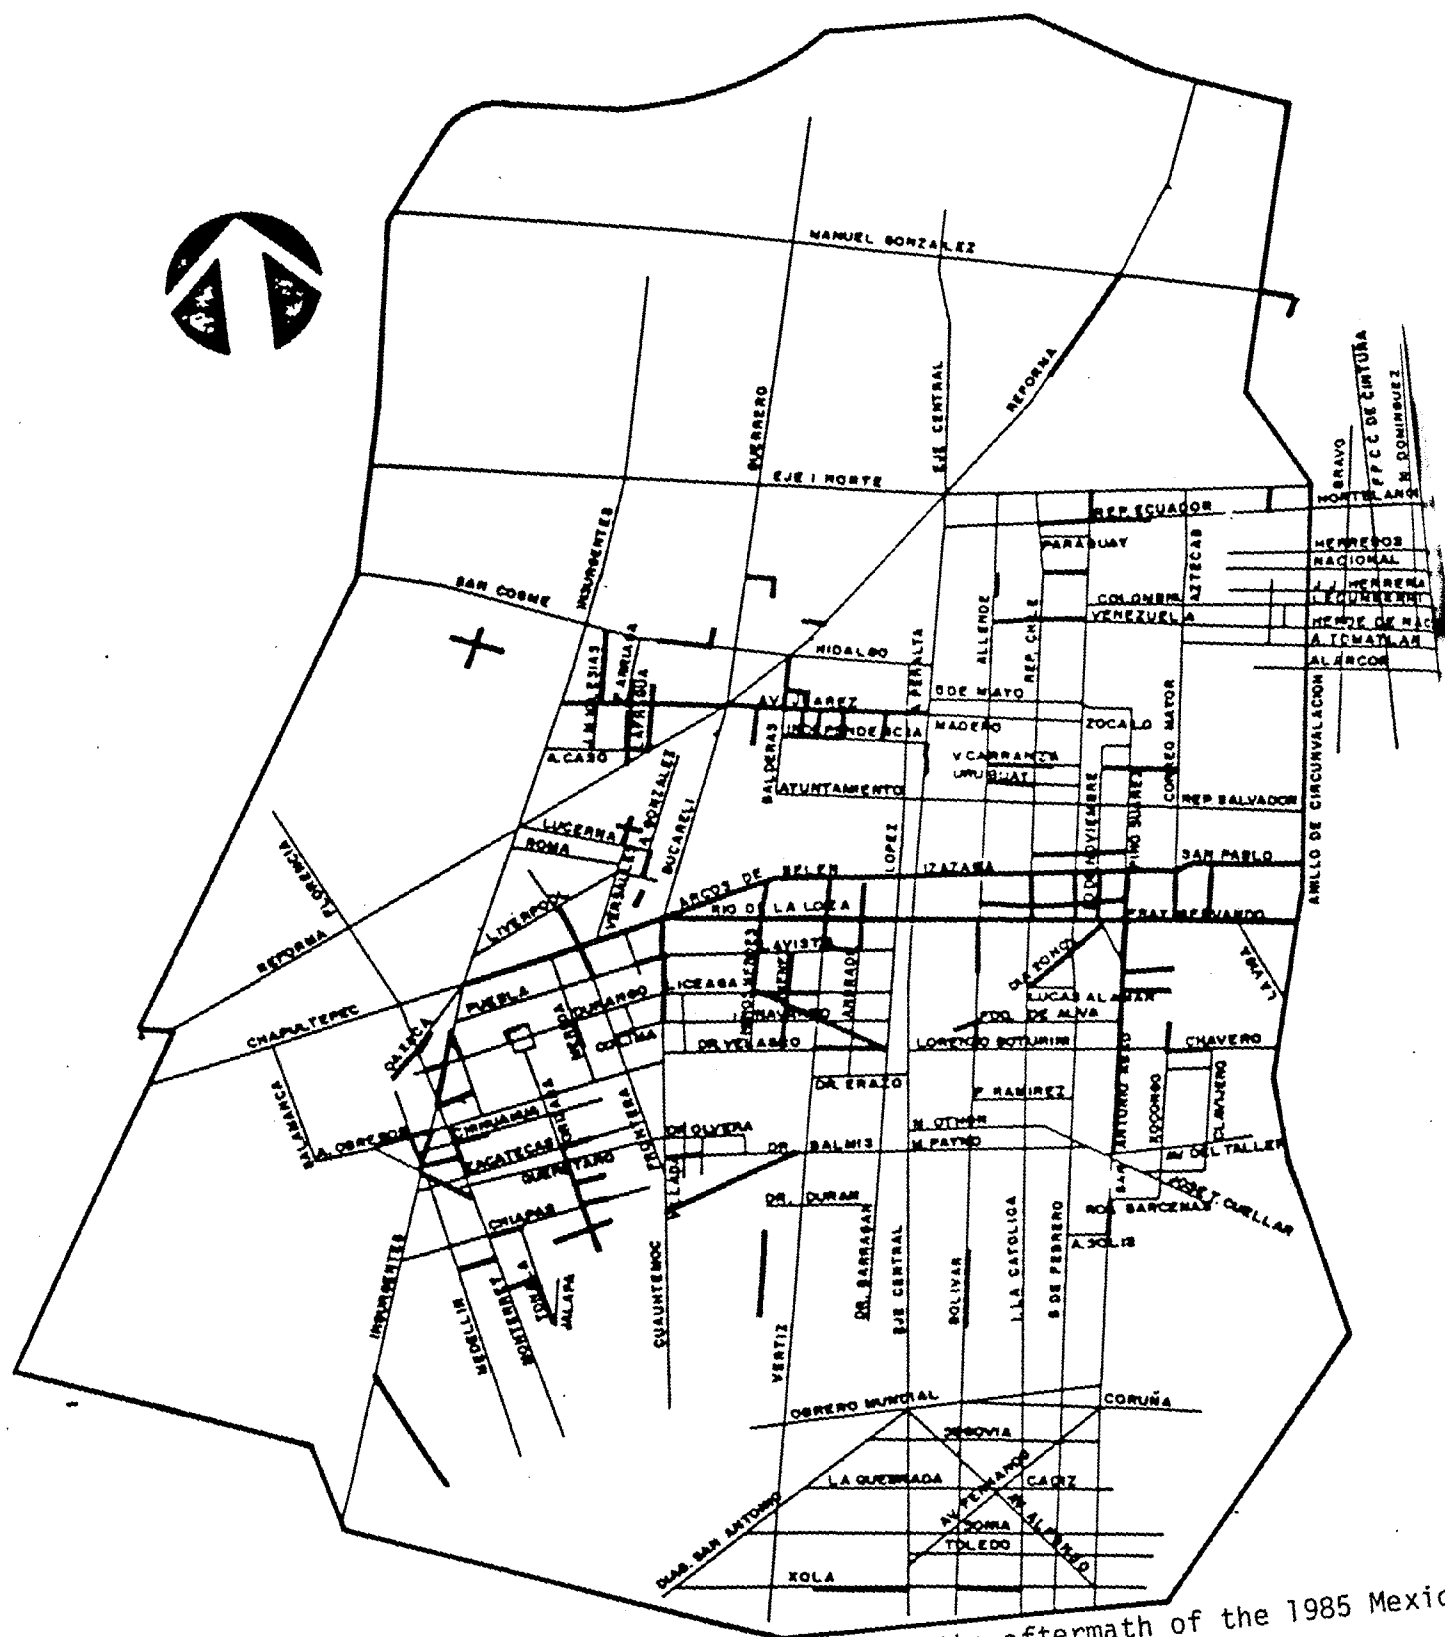
Figure 1. The map of severely damaged regions in the aftermath of the 1985 Mexico City earthquakes.

Upon the occurrence of the September 19, 1985 earthquake approximately 70% of the normal capacity of the Mexico City central transportation network was lost (Ref. 4). The loss of the street capacity in the central region was not due to structural damages to the streets alone. In fact, the latter was the least of the contributing elements.

The network capacity was mainly reduced due to blockages caused by structures collapsing into the streets and compounded by debris from collapsed structures stored in the streets as search, rescue, demolition, and clean-up progressed. Also contributing to the loss in capacity were the cordons used to minimize the threat from near-collapse structures and to facilitate rescue operations and heavy machinery assembly. In addition, at least one source (Ref. 8) identified the gathering of crowd (volunteers, relatives of victims, and on-lookers) as another element in the closure and capacity reduction of streets. Finally, a number of massive gridlocks in the hours following the 7:19 earthquake had effectively shut down many street links.

Most of these problems were concentrated in the central region of Mexico City shown in Figure 1. This is a zone whose primary streets are under the control and monitor of the Mexico City computerized traffic control system since 1982. Figure 2 also shows the distribution of the capacity reductions on a street-by-street basis within the affected network shown. The extent of disturbances within the area shown includes:

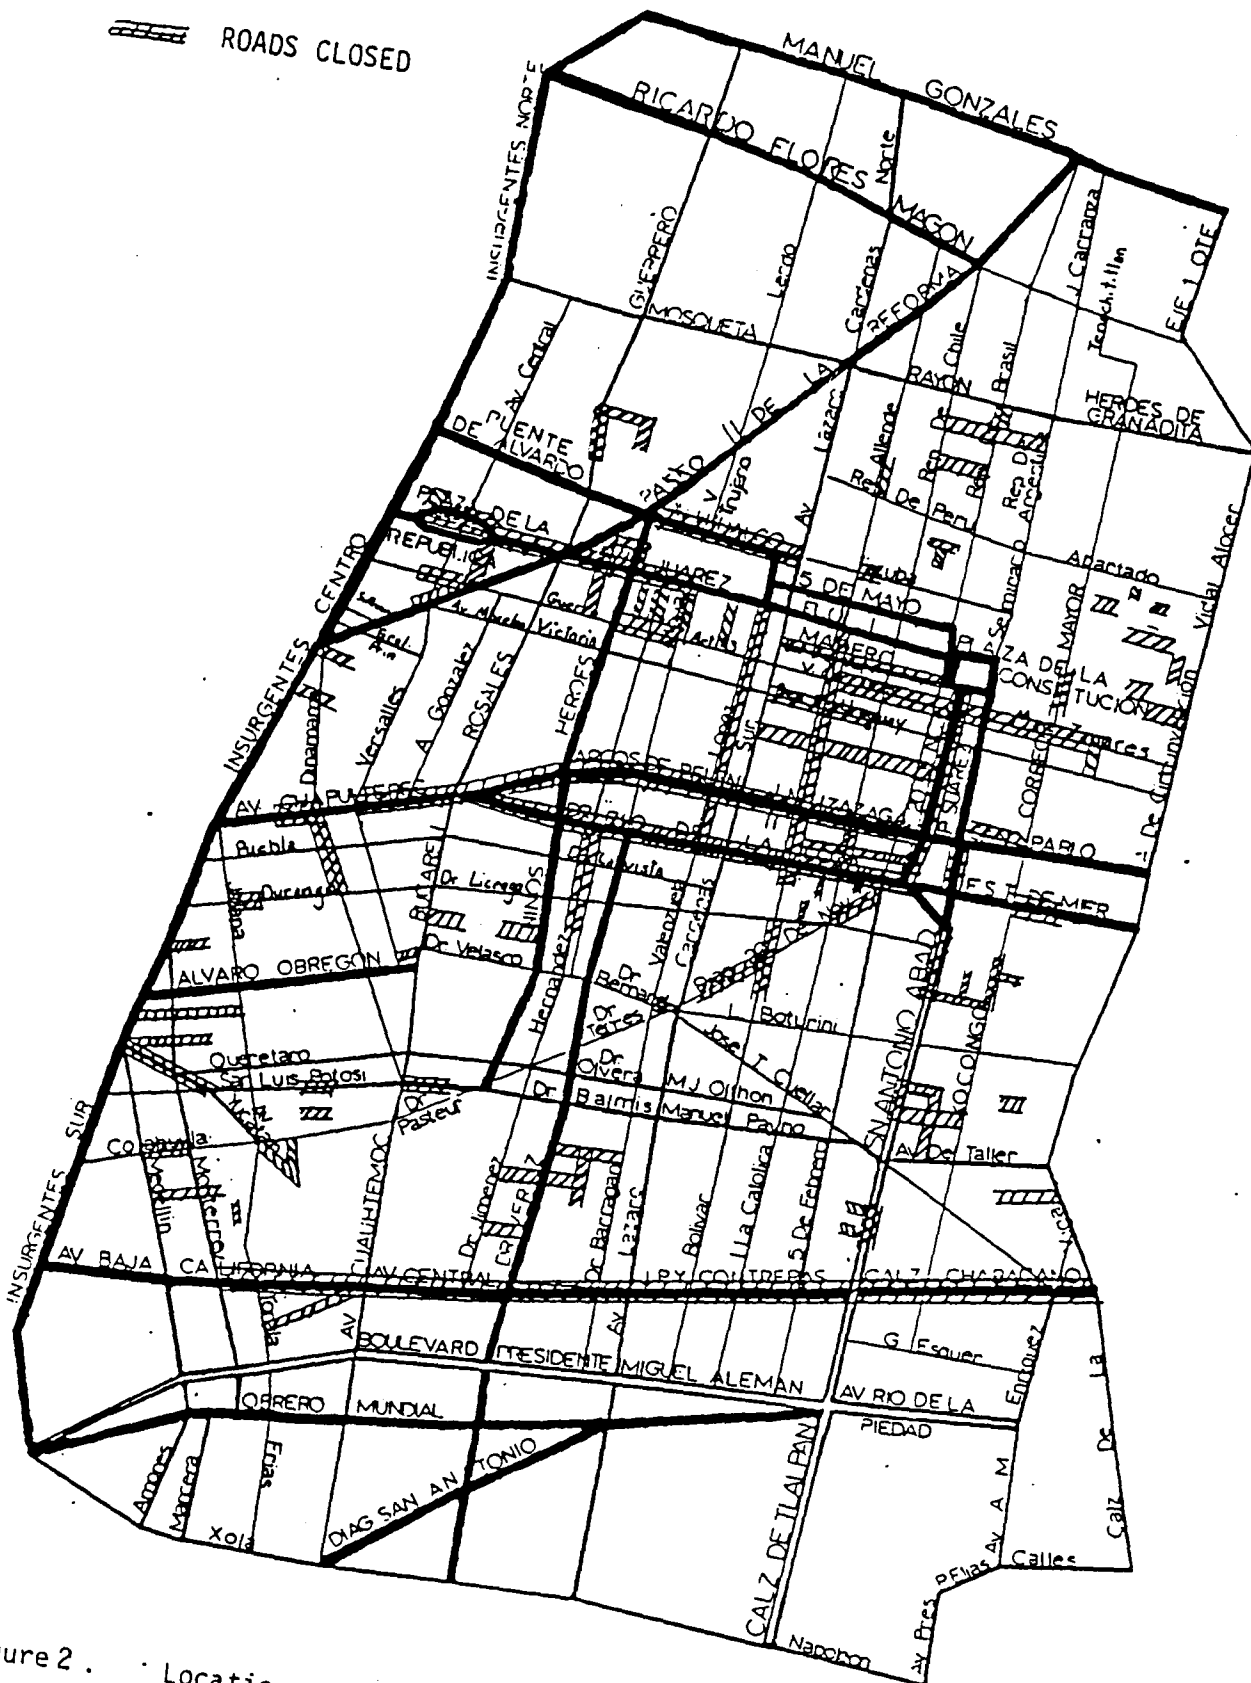
Figure 2. Location of streets closed to through traffic in the aftermath of the September 1985 Mexico City earthquake.

i) Access-Controlled Freeways	10.7 kms.
ii) Two-Way Avenues	19.0 kms.
iii) Ejes Viales*	68.9 kms.

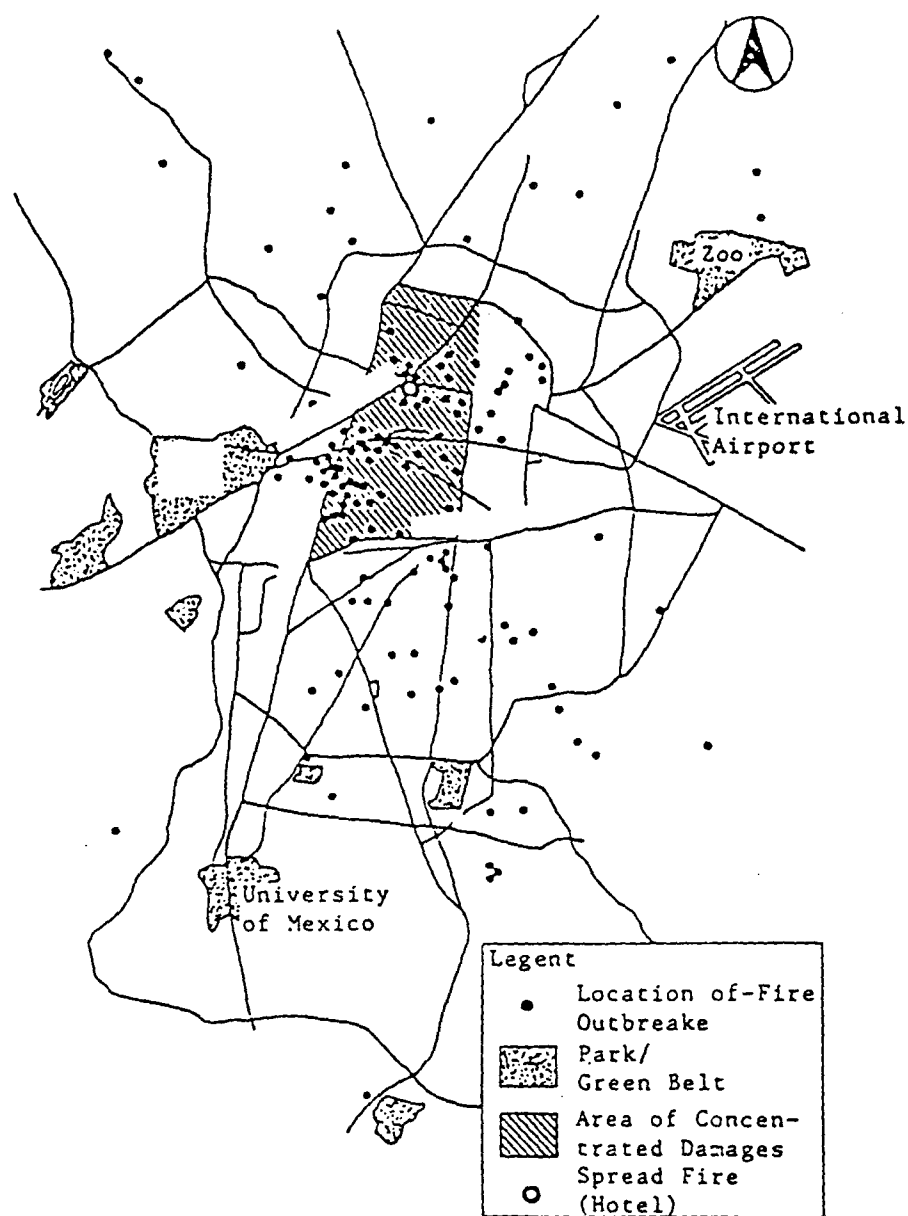
Figure 5. Location of fire outbreaks in the three days following the September 19, 1985 Mexico City earthquake (Ref.2).

Despite such limited resources, following the 1985 earthquake, the Mexico City fire brigade was forced to engage in activities as diverse as removing crushed walls, quenching fires, preventing gas leakages, and supplying water to medical facilities. Within the first 24-hour period after the earthquake, the fire brigade responded to 193 cases of fire and 236 cases of gas leakage (Ref. 2). In the three days after the earthquake, 351 cases of fire were reported; Figure 5 shows the loca-

tion of the major fire outbreaks.

In the aftermath of the earthquake, it was necessary to mobilize scarce medical resources to widely scattered location in the city. Sporadic fires had also broken out in many locations (Fig. 5). Emergency response agencies, generally understaffed and underequipped, had to make the most efficient use of their resources.
